Advisory Region Northern Gallatin

Forecast link: <u>GNFAC Avalanche Advisory for Wed Mar 28, 2018GNFAC Avalanche Forecast for Thu Mar 29, 2018</u> Northern Gallatin, 2018-03-28

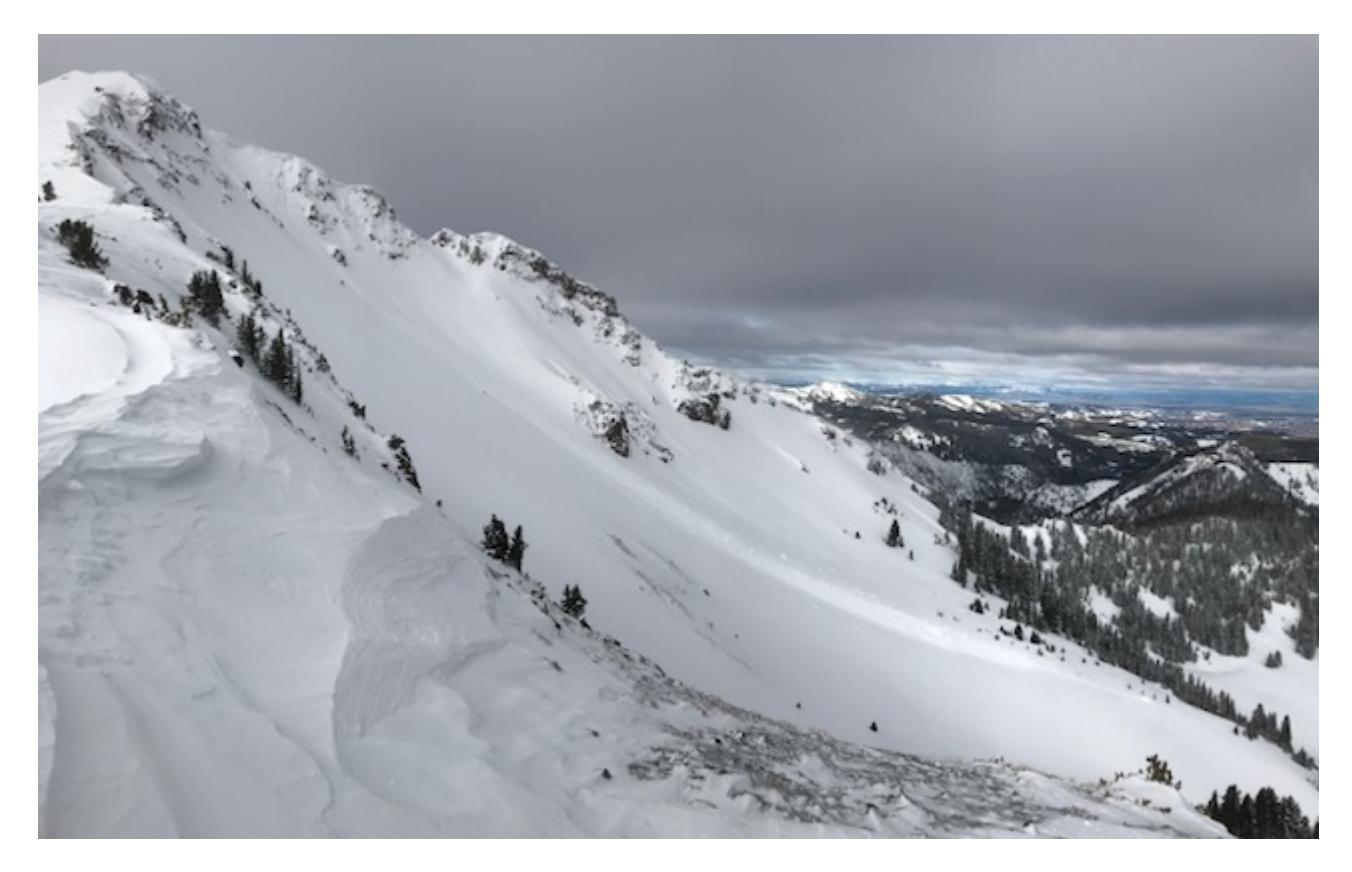
A skier found 2-6" thick wind slabs on the east face of Mt. Blackmore up Hyalite, and a cornice break (photo) that ran over 600 vertical feet down the north face. Photo: S. Casper
